INDOOR AIR QUALITY ASSESSMENT

**Bernardston Elementary School
Pioneer Valley Regional School District
School Road
Bernardston, Massachusetts**

Prepared by:
Massachusetts Department of Public Health
Bureau of Environmental Health Assessment
June, 2001

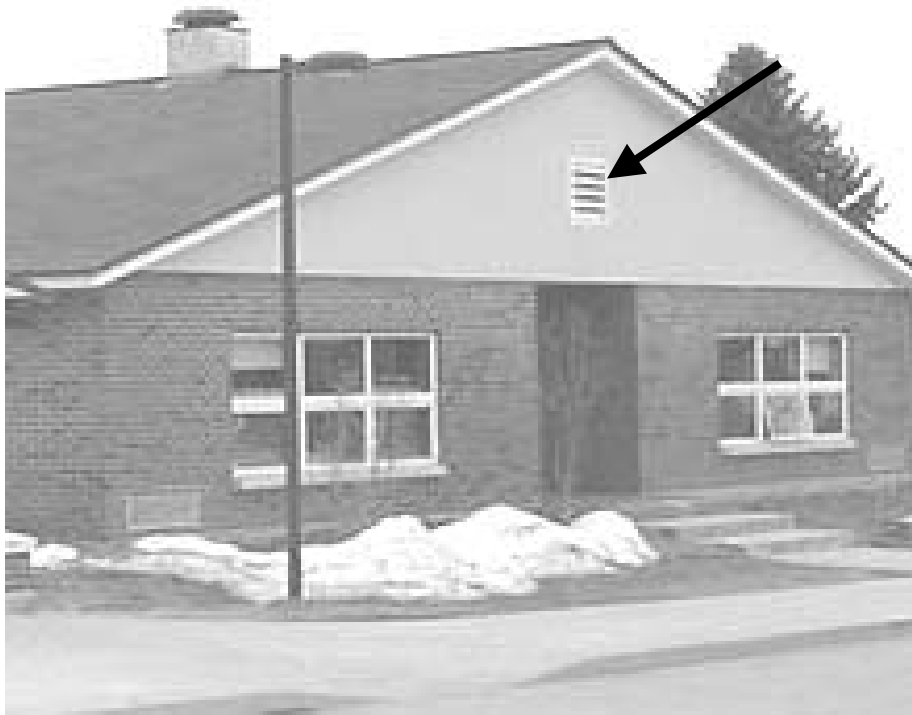
Picture 1

Several other conditions were noted during the assessment, which can affect indoor air quality. BEHA staff noted complaints related to exhaust infiltration from busses. These vehicles discharge and embark passengers in the front of the school building, near where a gable-mounted fresh air intake is located (see Picture 1). Idling

busses at the front of the building can result in vehicle exhaust entrainment by the mechanical ventilation system and open windows. Under certain weather conditions this may provide opportunities for exposure to combustion products such as carbon monoxide. Air monitoring for a constituent of vehicle exhaust (carbon monoxide) was measured in classrooms serviced by this fresh air intake during bus embarkation the afternoon of the assessment. No vehicle exhaust odors or measurable levels of carbon monoxide were detected within these classrooms at the time of the assessment.

AHU Fresh Air Intake

10. Consider relocating bus passenger discharge and embarkation to avoid vehicle exhaust entrainment by the ventilation system during southerly wind conditions.

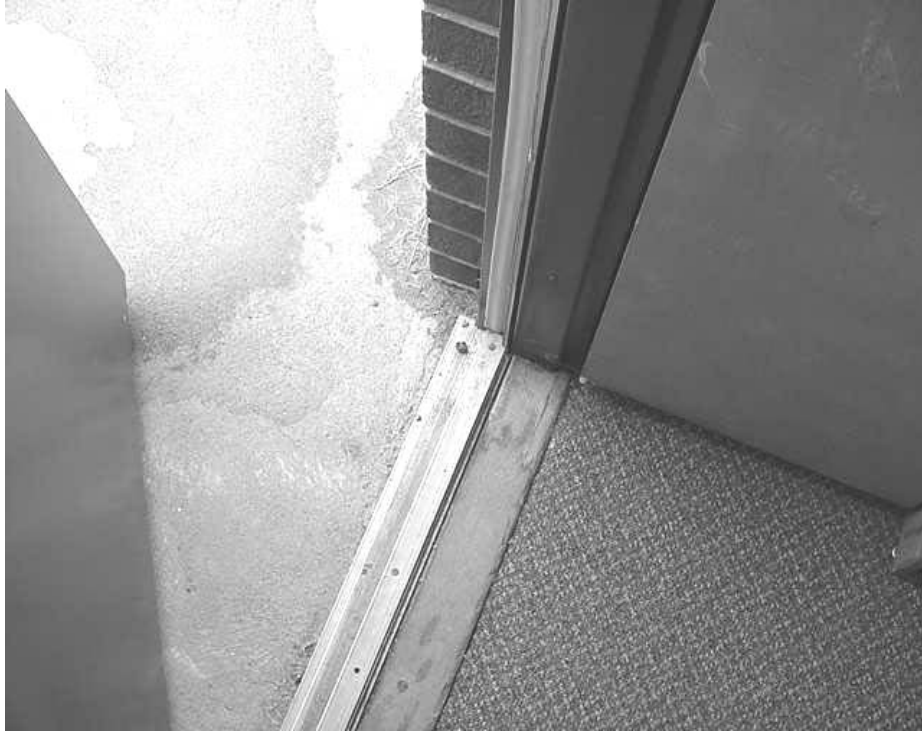
Picture 2

Water penetration was noted through the exterior doorframes in the wing of classroom 102. Water damage to the wooden threshold indicates that water may be moistening the carpeting around the doorframe (see Picture 2). The source of water appears to be an incomplete gutter that is installed over the classroom exterior doors (see Picture 3). No gutter and downspout system is installed along the edge of the peaked roof. Rainwater collecting on the roof rolls off the edge to collect and drain from the building. This design is problematic due to cement slabs used as exterior door thresholds existing beneath the roof edge. Splashing rainwater can lead to chronic moistening of the exterior wall and doors. These gutters are not connected to downspouts to direct rainwater from the base of the building, and has resulted in chronic moistening of the

Water Damage to Door Threshold in Close Proximity the Wall-To-Wall Carpeting

- thresholds. Recaulk the door threshold and doorframe to prevent water penetration. Consider removing carpeting from door threshold.
3. Examine the feasibility of redirecting groundwater from the slope toward the kitchen door. This may be accomplished by installing a gutter/downspout system to collect rainwater from the roof that is falling from the eave into the slope towards the kitchen door. A raised section (called a berm) of tarmac installed at the wings wall corner could be used to direct water away from the kitchen door and also serve as a speed bump (see Picture 13).

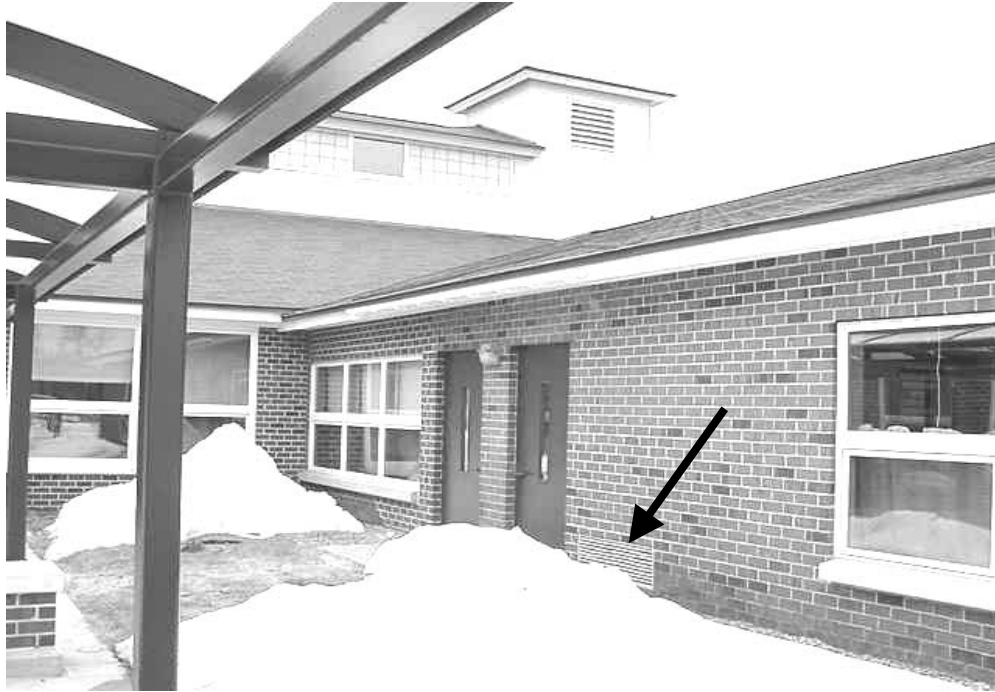
exterior brickwork, as well as the louvers of the abandoned fresh air intake vent for the unit ventilator (univent) in classroom 102 (see Picture 3). Wetting of the louvers can lead to water penetration into the abandoned univent.

As mentioned previously, several classrooms in the front of the building are equipped with univents that were abandoned after the 1997 renovations. The fresh air intake vents are open to the outdoors (Picture 3) and can serve as a means of drafts and water vapor to penetrate into the building. In addition, these vents can also serve as a means for water from melting snow covering the vents to penetrate into the interior of each univent. Abandoned ventilation equipment should have the fresh air intakes rendered air and water tight to prevent moisture from breaching the building envelope and leading to uncontrolled drafts and water penetration.

Open Ended Gutter over Exterior Doors, Note Darkened Wall Brick Which Indicates Repeated Water Moistening, Arrow Denotes Abandoned Univent Fresh Air Intake

1. Remove plant from floor in computer room. Remove water damaged carpeting beneath the plant. Disinfect the nonporous material below the removed carpeting with an appropriate antimicrobial agent and then clean thoroughly with soap and water. Replace carpeting as needed and avoid placing plants on carpeting.
2. Install downspouts at either end of the gutter system shown in Picture 3 to prevent splashing rainwater from damaging the exterior wall and penetrating through door

4. Render univent fresh air intakes airtight and watertight.
 5. Adjust the fresh air intakes to deliver more fresh air to various areas.
 6. For buildings in New England, periods of low relative humidity during the winter are often unavoidable. Therefore, scrupulous cleaning practices should be adopted to minimize common indoor air contaminants whose irritant effects can be enhanced when the relative humidity is low. To control for dusts, a high efficiency particulate arrestance (HEPA) filter equipped vacuum cleaner in conjunction with wet wiping of all surfaces is recommended. Avoid the use of feather dusters. Drinking water during the day can help ease some symptoms associated with a dry environment (throat and sinus irritations).

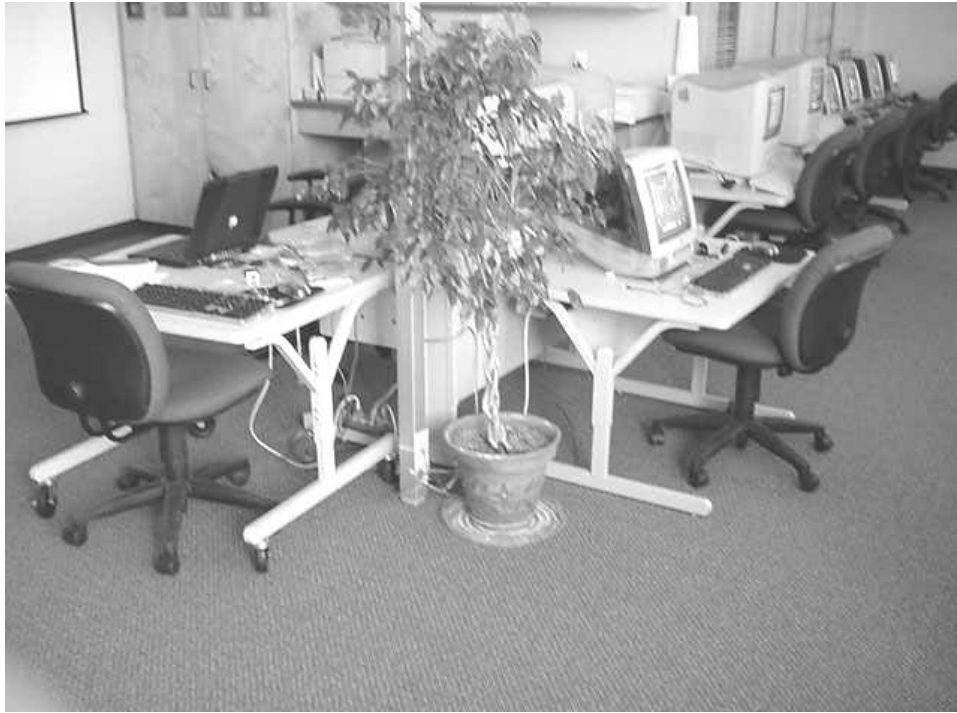
Picture 4

A musty/mold-like odor was detected in the computer room. A plant was observed over water stained carpeting in this room (see Picture 4). Mold colonization of the carpet from repeated moistening due to plant watering is the most likely cause of this odor. The American Conference of Governmental Industrial Hygienists (ACGIH) recommends that carpeting be dried with fans and heating within 24 hours of becoming wet (ACGIH, 1989). If carpets are not dried within this time frame, mold growth may occur. Water-damaged carpeting cannot be adequately cleaned to remove mold growth. The application of a mildewcide to moldy carpeting is not recommended. Plants were noted in other areas. In one instance plants were stored inside cardboard boxes, which doubled as drip pans (see Picture 5). Cardboard is a porous material, which if wetted repeatedly, can provide a medium for microbial growth. Plants should be equipped with proper drip pans and be located away from the air stream of mechanical ventilation to prevent aerosolization of dirt, pollen or mold.

Plant On Carpeting in Computer Room

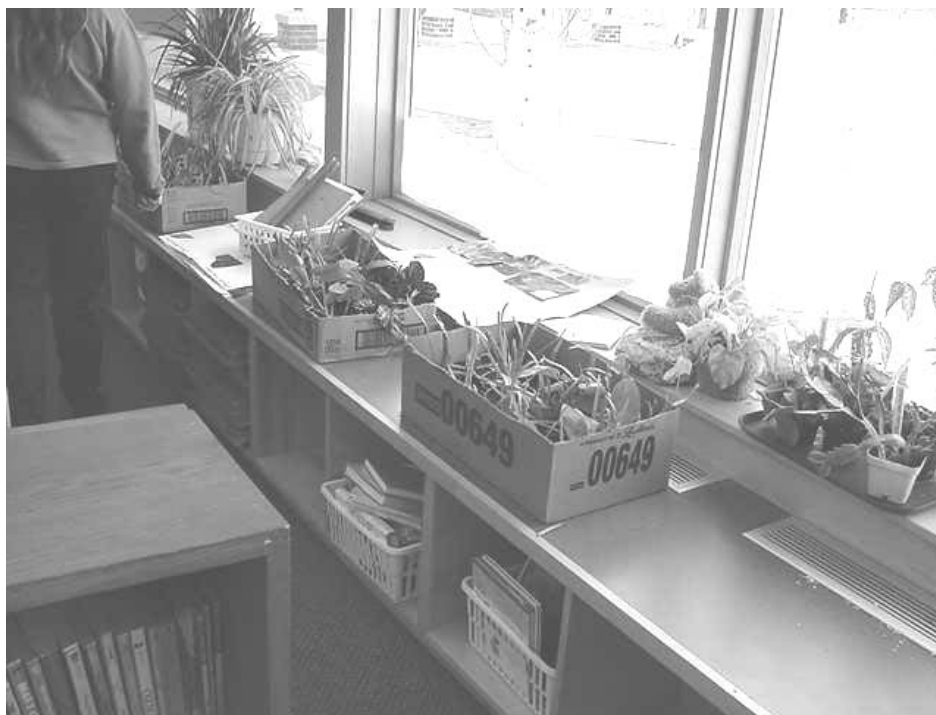
Picture 5

Plants In Cardboard Boxes

7. Discard cardboard used as drip pans for plants. Plants should be equipped with drip pans of a non-porous material (e.g., plastic). Examine drip pans periodically for mold growth and disinfect areas with an appropriate antimicrobial where necessary.

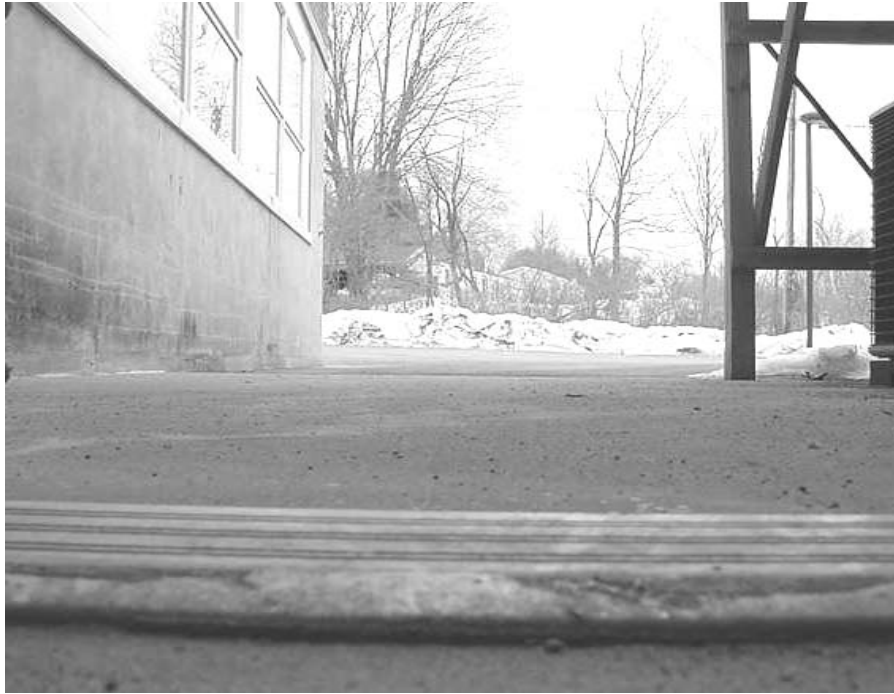
Picture 6

PVRSD officials reported a chronic problem with water penetration through an exterior door in the cafeteria. No drain exists outside of the kitchen door threshold to remove collected water. The pavement around this door slopes towards the cafeteria door (see Picture 6). The pattern of sediment on the tarmac also indicates that rainwater follows the building exterior wall and travels down the slope towards this door (see Picture 7). Above this area is a section of the roof eave that does not have a gutter downspout system. Rainwater from this section of the roof falls directly into this area, exacerbating the collection of water.

Ground Level Shot of Kitchen Door Threshold, Note Lack of Drain and Slope towards Threshold

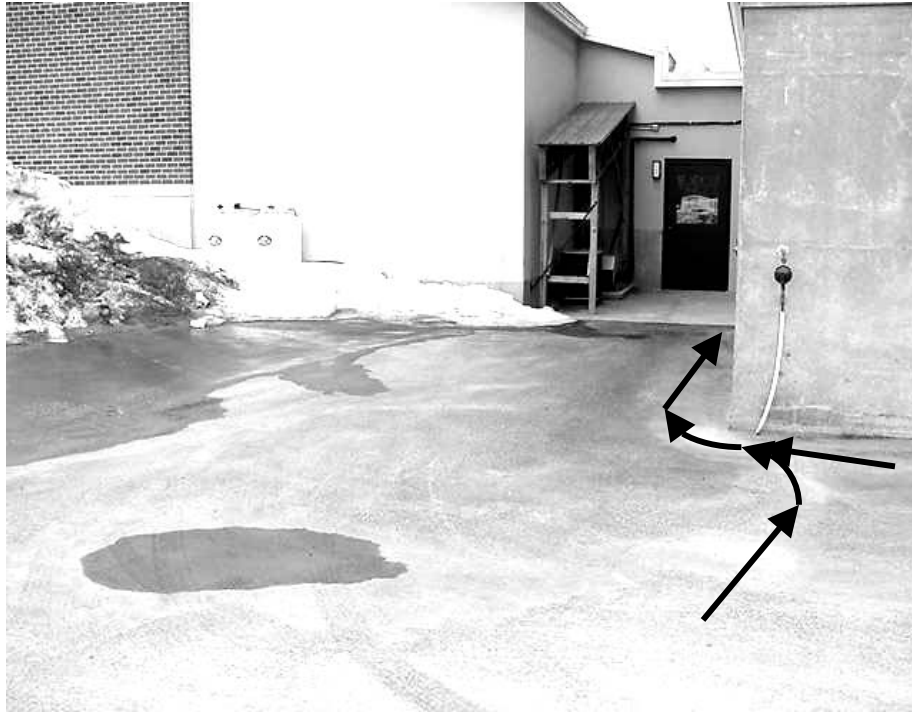
Picture 7

Tarmac Sloping towards Kitchen Door, Arrows Denote Rainwater Pathway as Indicated by Collected Sediment

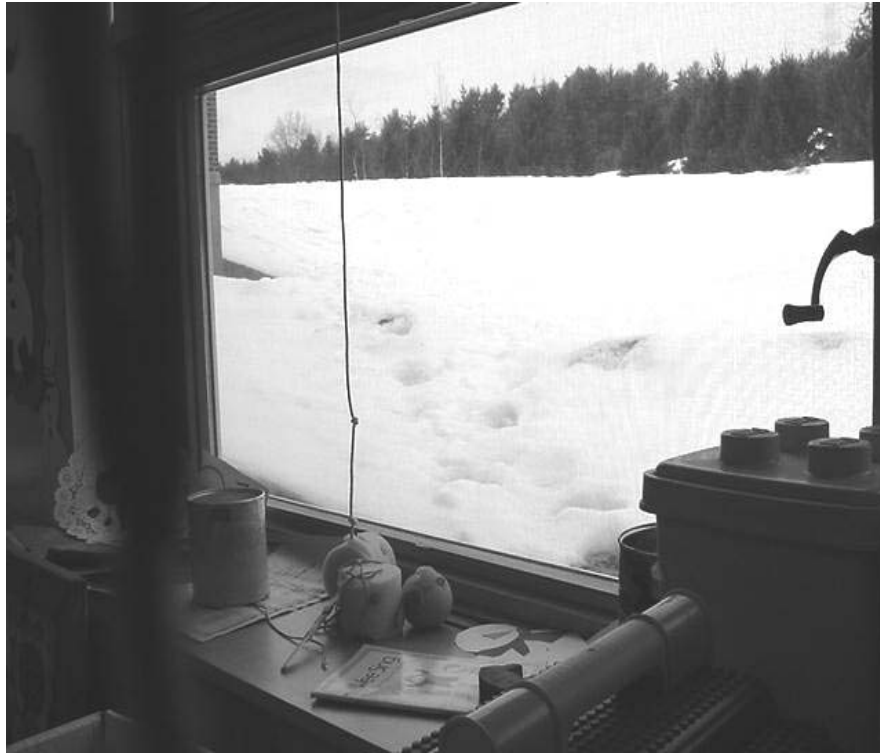
Picture 8

Also contributing to the problem is the high water table beneath this section of the building. The land on the opposite side of the kitchen wing slopes toward the cafeteria wall (see Picture 8). The boiler room, which is also in the general area of the cafeteria, has a hole in the floor. A plastic-lined hole was found filled with groundwater to a level of 1-2 inches below the floor (see Picture 9). With the high water table beneath the cafeteria wing, efforts to redirect runoff from the roof and parking lot should be made to prevent further flooding of the cafeteria/kitchen.

Ground Sloping towards Cafeteria Wall on Wing Wall opposite Kitchen Door

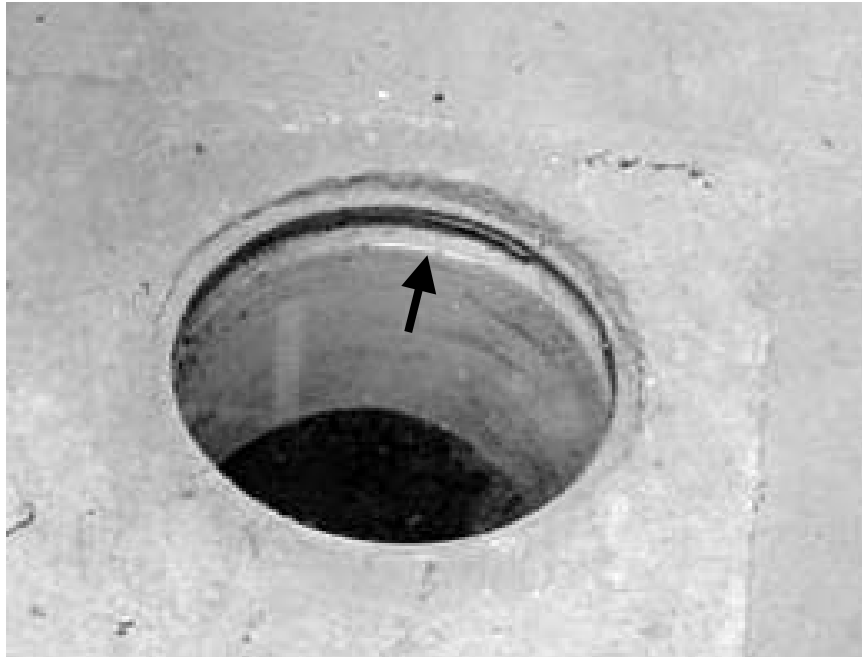
Picture 9

Collected Groundwater in Hole in Boiler Room, Arrow Indicates Water Level Line on Side of Hole

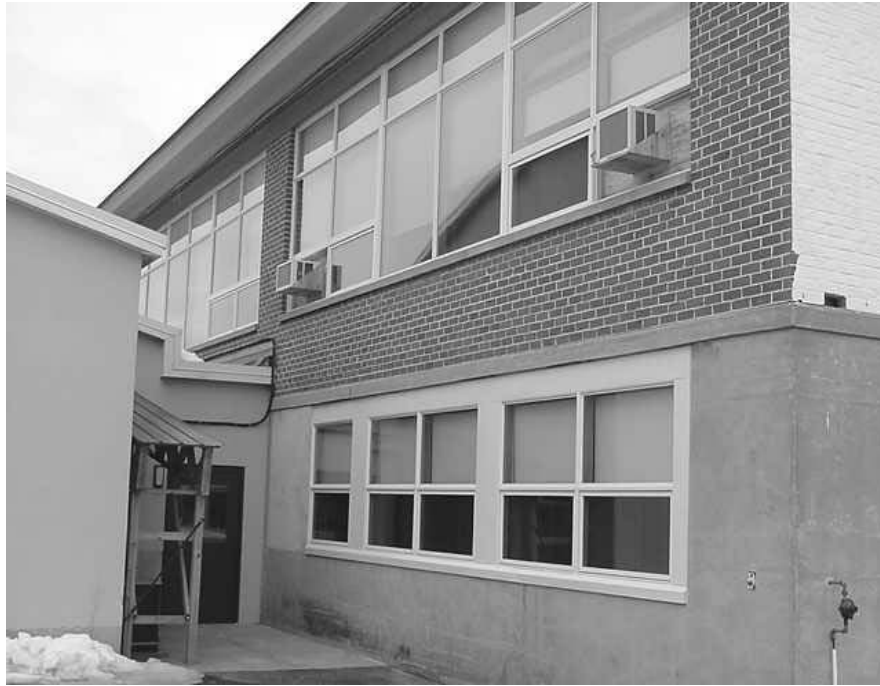
Picture 10

PVRSD personnel also reported that vehicle exhaust odors have been reported in classrooms above the kitchen exterior door that serves as the loading dock area for the school (see Picture 10). The classrooms above this area are installed with window-mounted air conditioners, which may be of a type that introduces fresh air from outdoors. The operation of these window-mounted air conditioners, as well as the opening of windows above the kitchen door, can serve as pathways for vehicle exhaust to penetrate into classrooms from idling delivery vehicles. M.G.L. chapter 90 section 16A prohibits the unnecessary operation of the engine of a motor vehicle for a foreseeable time in excess of five minutes (MGL, 1986).

Window-Mounted Air Conditioners above Loading Dock

9. Post a sign by the loading dock instructing vehicle operators to shut down engines in compliance with Massachusetts law. Schedule deliveries after school hours. If no other option, provide teachers in rooms above the loading dock with a schedule for deliveries so that window-mounted air conditioners can be deactivated and windows closed during deliveries to prevent vehicle exhaust odor penetration.

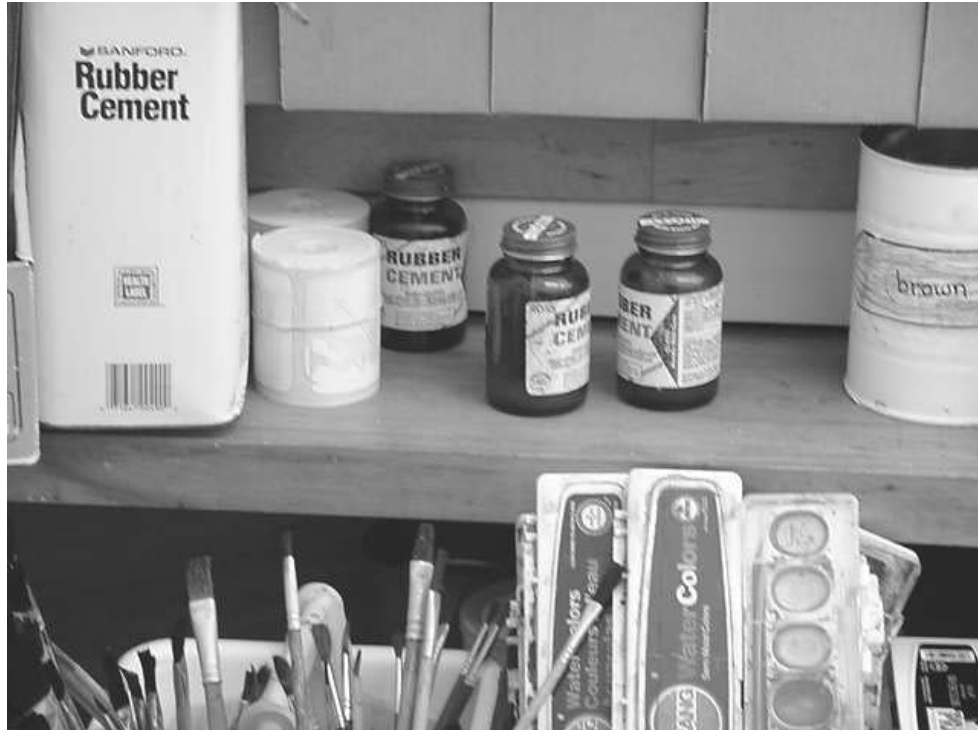
Picture 11

Rubber cement- Rubber cement (see Picture 11) contains n-hexane, which can be irritating to the eyes, nose and throat; in addition n-hexane is an extremely flammable material. Local exhaust ventilation should be utilized when this material is used.

Containers of Rubber Cement

11. Discontinue the use of artificial snow.
 12. Consider replacing art and school supplies containing materials that require labeling under LHAMA with water-based materials to reduce VOCs in classrooms.

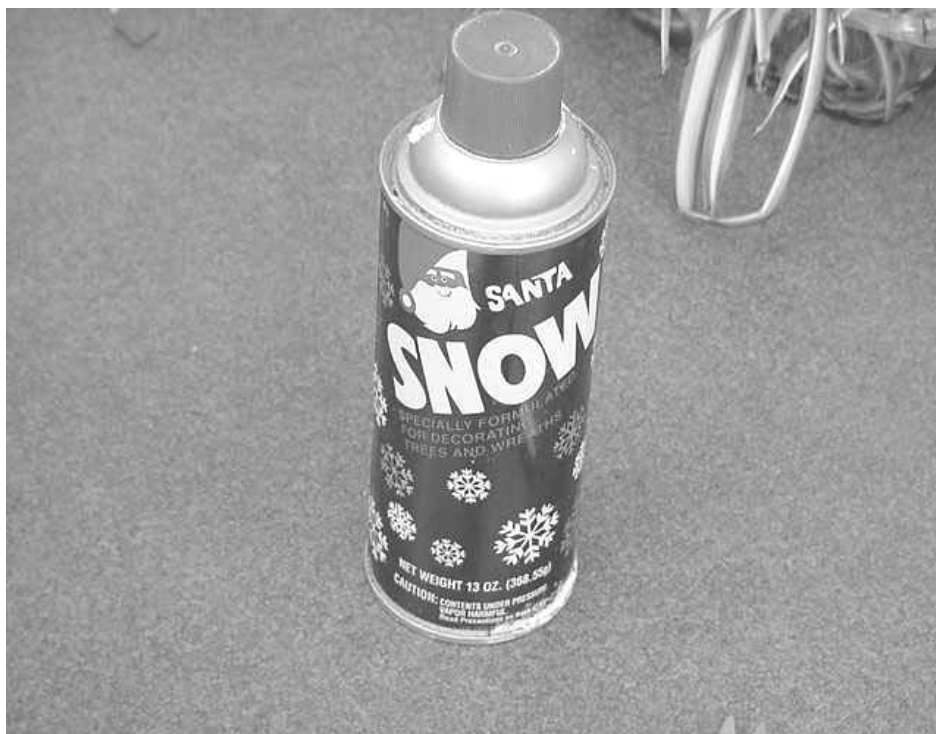
Picture 12

*Artificial Snow-*This spray product, used to frost windows, contains flammable materials. The product contains heptane and xylene (see Pictures 12) (CPC,

1998). Heptane and xylene are substances that are associated with irritation to the eyes, nose and throat. It should only be used with proper exhaust ventilation and not with children in close proximity.

Artificial Snow Container
